WHITE PAPER

INVESTIGATING SEALING ISSUES IN FLEXIBLE PACKAGING PRODUCTS

Dr. Steve Mirams
Technical Service Specialist
November 2017

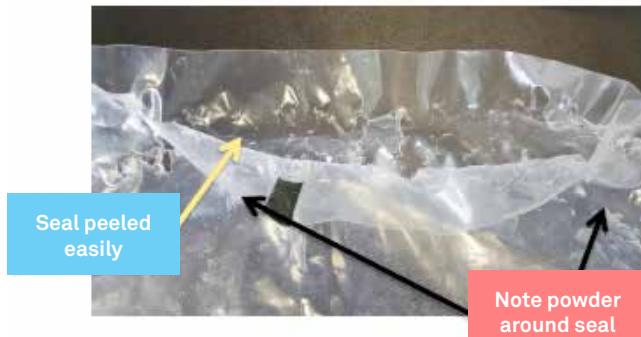
Figure 5. Seal failure in many seals due to peeling, particularly where powder was observed.

During initial trials of a new food-packaging operation, the processor noticed that most packs were not sealing. As indicated in Figures 5 and 6, a visual inspection of the seal failures suggested a major problem.

All attempts to adjust the sealing process failed to produce consistent seals. It was likely that the presence of powder (from the product being packaged) around the sealing area was affecting the sealing process, especially as the quantity of powder varied.

To overcome this problem, the packaging machine was redesigned to prevent powder forming in the sealing area.

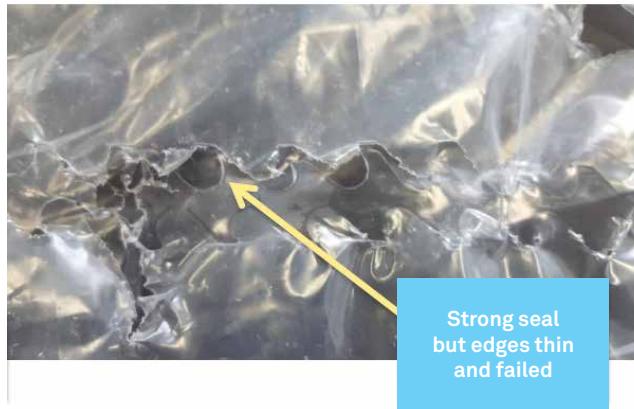
Figure 6. Thin and torn edges adjacent to the strong seal indicate excessive temperature in sealing, particularly in areas where little powder was observed.

Seal failure due to peeling indicates poor polymer entanglement across the seal. The normal corrective action is to increase the sealing temperature. Figure 6 shows the result when the sealing temperature was raised. The film layers formed a strong seal, but the higher temperatures caused the film at the edges of the seal to become so thin and weak that the film tore.
